# MONUMENT RECORD

Corner ID: **VanBu\_U23**

## Quarter Corner

Sections 35 & 36 - T08N-R02W, 2nd P.M.  
Van Buren Township, Monroe County, Indiana

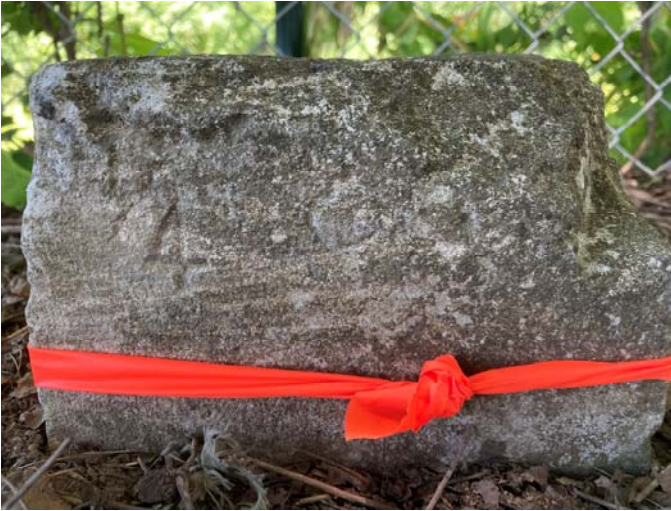
*Photo Orientation & Description: Looking north at Van\_Bu\_U23*

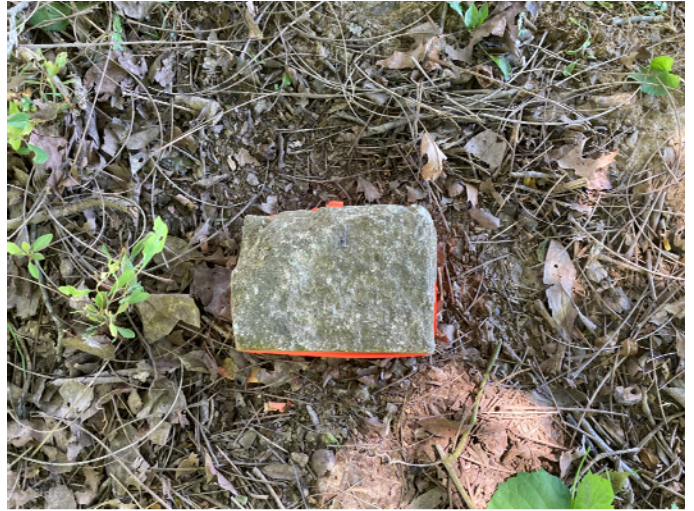
*Photo Orientation & Description: Looking down at VanBu\_U23*

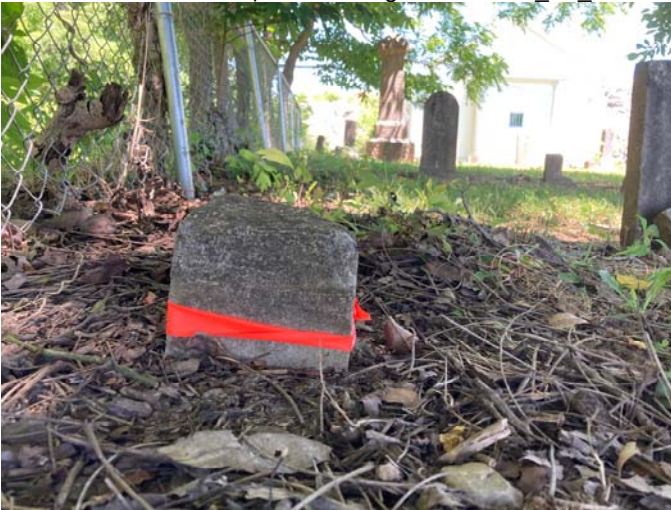
*Photo Orientation & Description: Looking east at Van\_Bu\_U23*

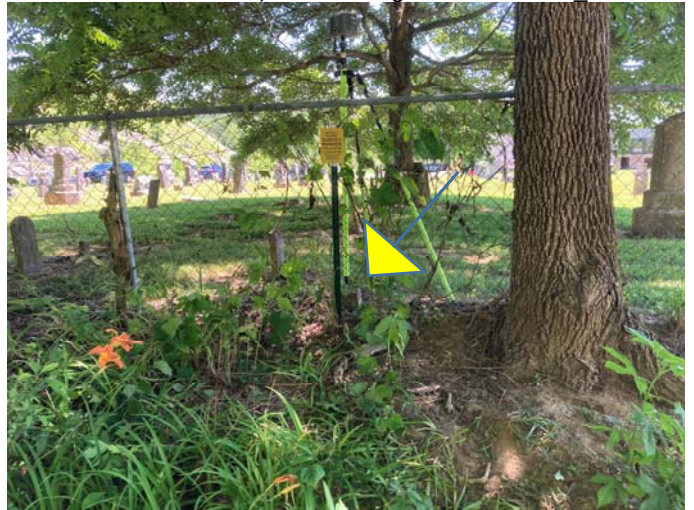
*Photo Orientation & Description: Looking south at VanBu\_U23*
